Temperature and rockfalls monitoring activities at Aiguilles Marbrées North face (Mont Blanc Massif, France)

M.Curtaz (1), M. Vagliasindi (1), U. Morra di Cella (2), P. Pogliotti (2), R. Roncella (3), A.M. Ferrero (3)

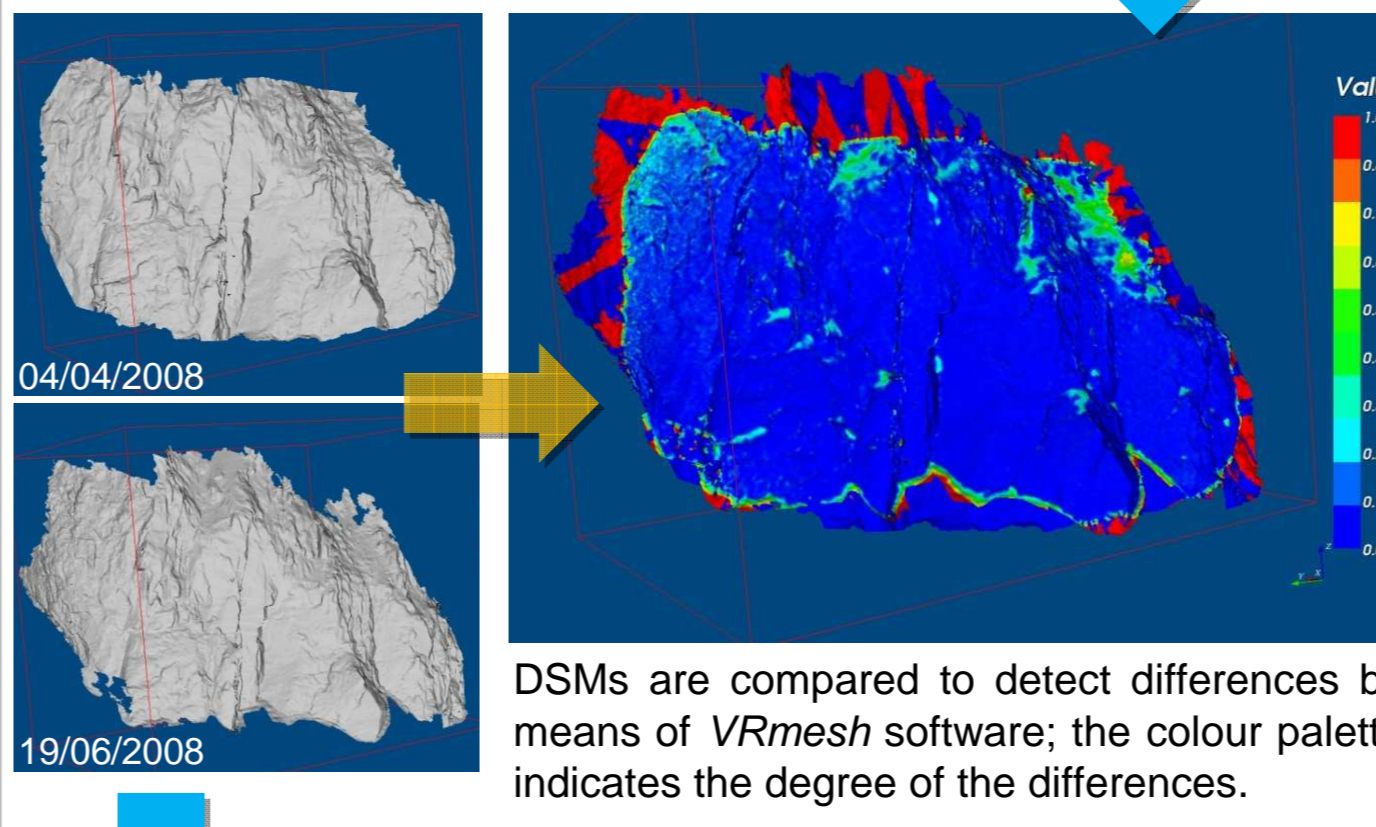
STEP 3: DSM COMPARISON

DSMs are compared to detect differences by means of VRmesh software; the colour palette indicates the degree of the differences.

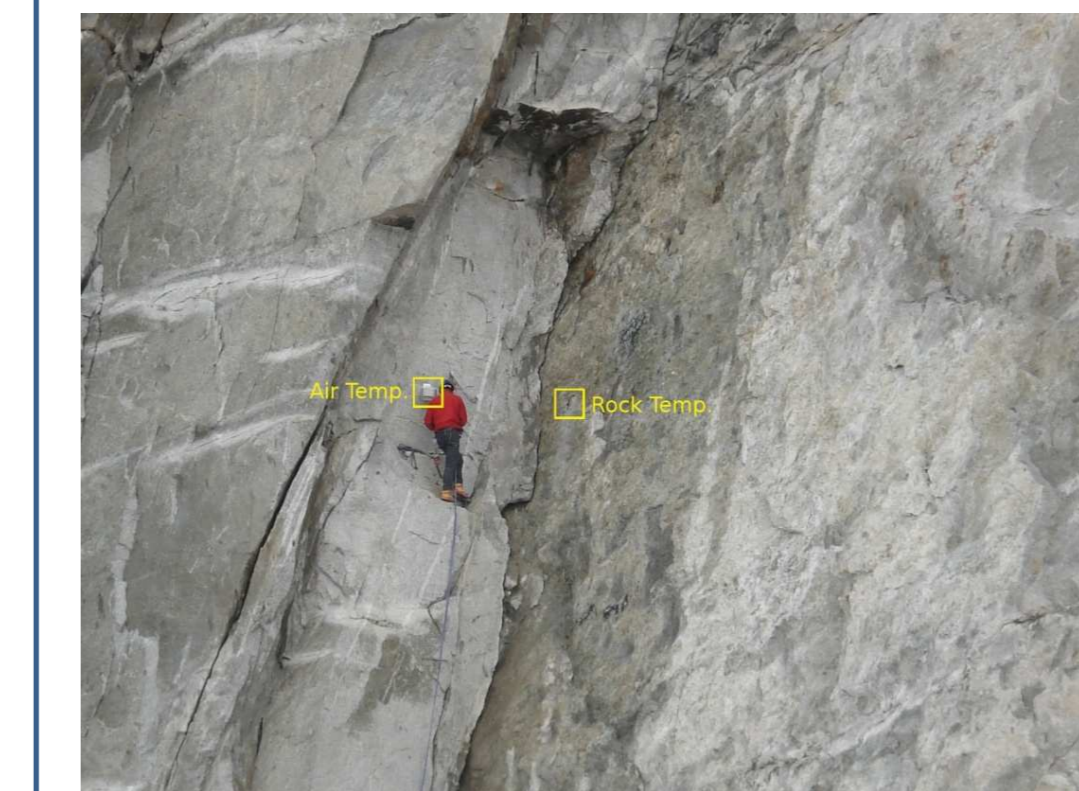
Fig 4. Sensors position.

Sensors for both rock and air temperature measurements are installed in the upper part of the 2007 detachment zone (Fig 4). The surface rock temperature is monitored since September 2008 at three different depths (3, 30 and 55 cm) by a PT1000 based mini-logger with a frequency of 10 minutes. To reduce data loss due to damages or malfunctions in June 2009 a new system equipped with GPRS modem was settled down (Fig 5). Air temperatures and humidity are measured near the rock temperature sensors and inside a radiation shield in order to avoid the influence of direct solar radiation. Rock temperature at all depths and air temperature time series are reported in Fig 7 and 8. The scatter plot of Fig 9 shows that air temperature is almost always below the surface rock temperature (3 cm depth) due to the influence of solar radiation.

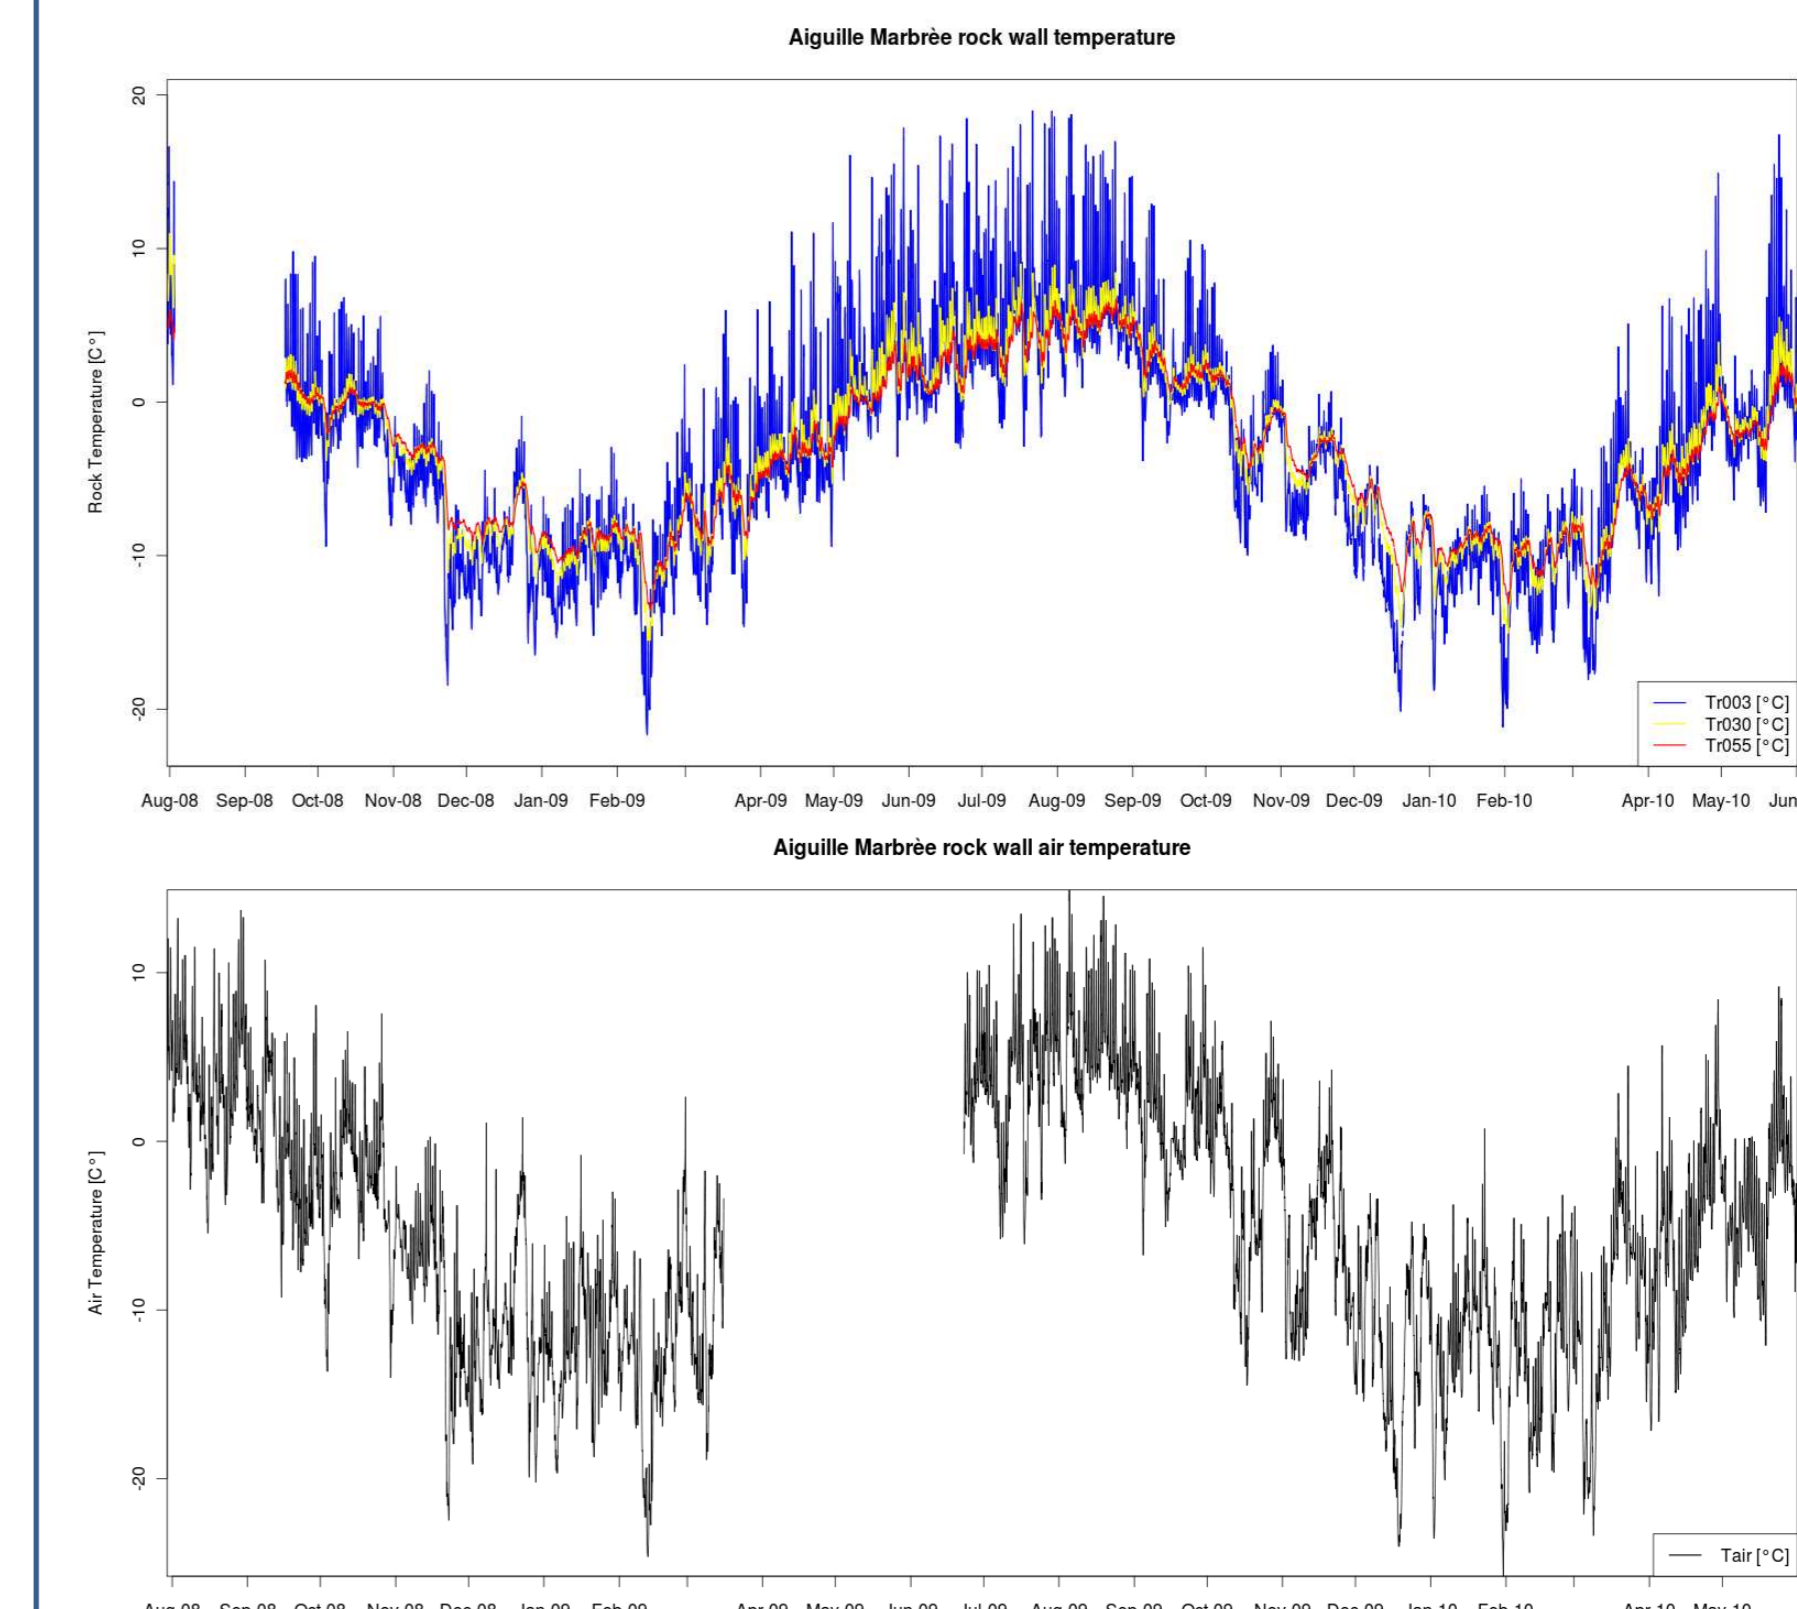
Fig 7, 8. Rock temperature at all depths and air temperature time series.

The statistics (Tab 2) computed over the hydrological year 2008/2009 on all the sensors confirm the probable condition of permafrost on the rockwall (mean annual rock temperatures below -2 °C); MAAT is around -4.6 °C. February is the coldest month while August is the hottest. Freeze-thaw cycles (Zero crossing days) are strongly limited to rock surface while the number of frozen days (days with maximum daily temperature below zero) are quite similar at all depths.
